Intel® E8500 Chipset North Bridge (NB)

Specification Update

June 2005

Document Number: 306747-002

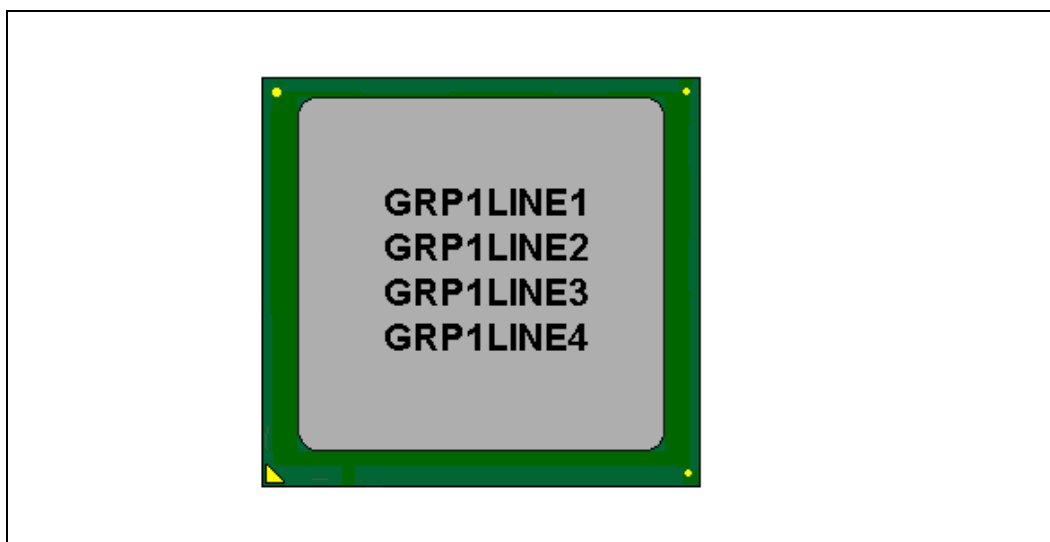
Figure 1. Top-Side Marking Example (optional)

Stepping	QDF-Spec	S-Spec	Top Marking	Notes
B0	QE34ES	N/A	NQ84001TNB	
B0	QG54	N/A	QG84001TNB	Lead free package
